US 281 Colorado River Bridge, Marble Falls, Texas

When completed, the US 281 Colorado River Bridge (**Figs. 10, 11, 12 and 13**) will become the eleventh segmental bridge in the **Texas Department of Transportation's (TxDOT)** inventory, continuing a history of successful segmental implementation in Texas that began in 1973. **TxDOT** awarded the contract to **Archer Western Contractors**. Construction of the northbound structure commenced on December 6, 2010.

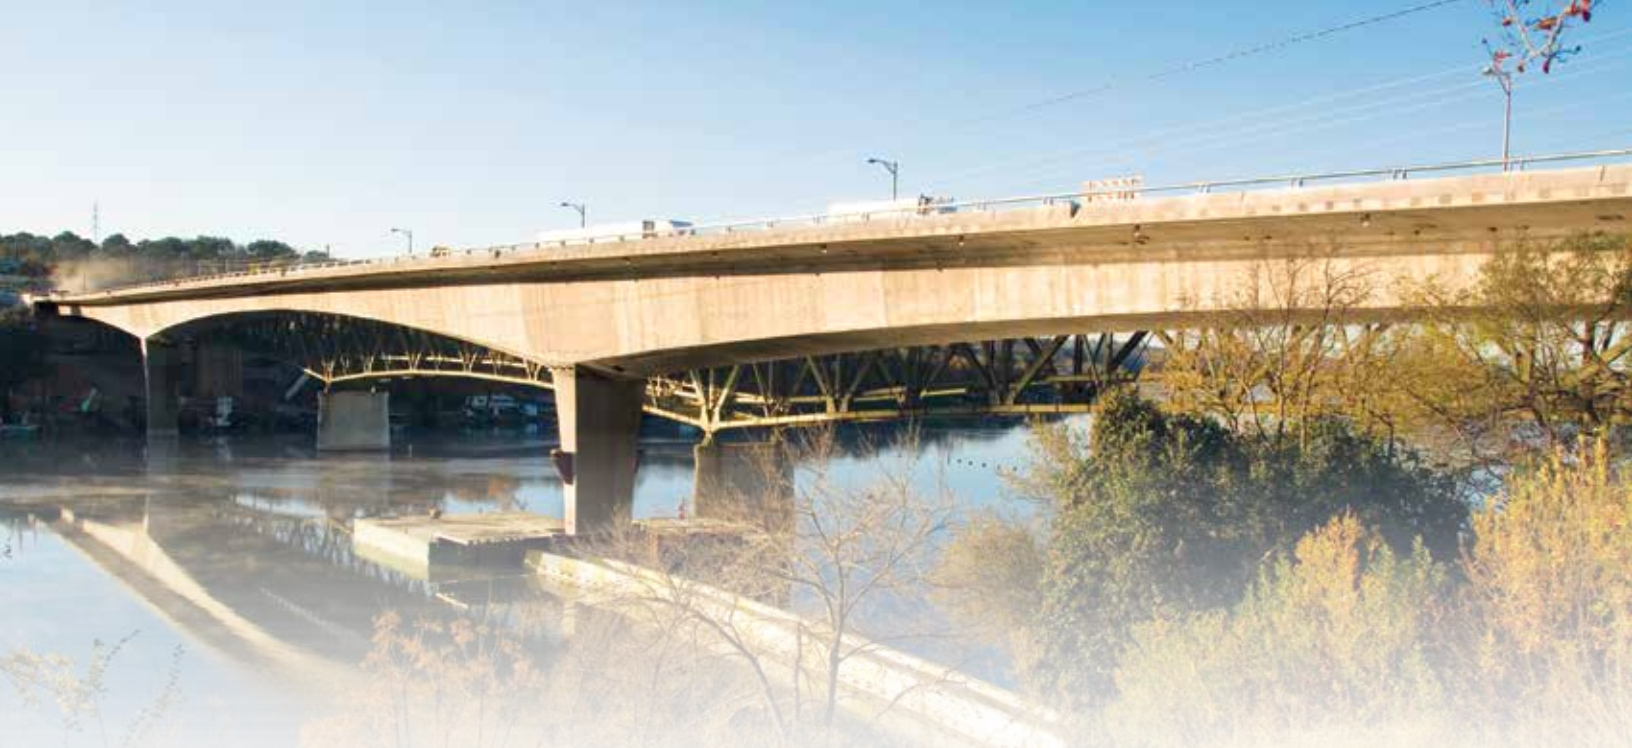
Figure 10 –
US 281 Colorado River Bridge over Lake Marble Falls. (Photo Courtesy of Archer Western Contractors)

The twin structures replace a deck truss built in 1935 and widened in 1975. The existing bridge, with 4 narrow traffic lanes and one sidewalk, is functionally obsolete. Each new bridge will provide 2 standard traffic lanes in one direction, shoulders, and a 6 ft. sidewalk. The bridges are single cell boxes with spans of 274 ft., 410 ft., and 274 ft., built using the cast-in-place balanced cantilever method.

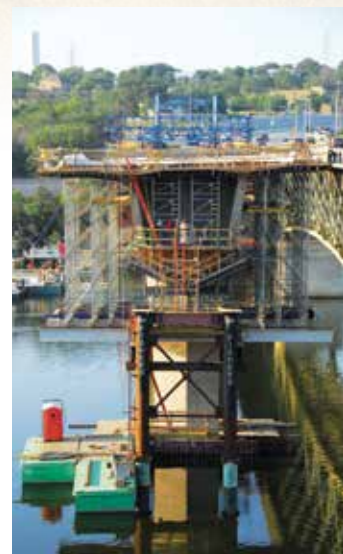
Figure 11 –
US 281 Colorado River Bridge over Lake Marble Falls. (Photo Courtesy of Archer Western Contractors)

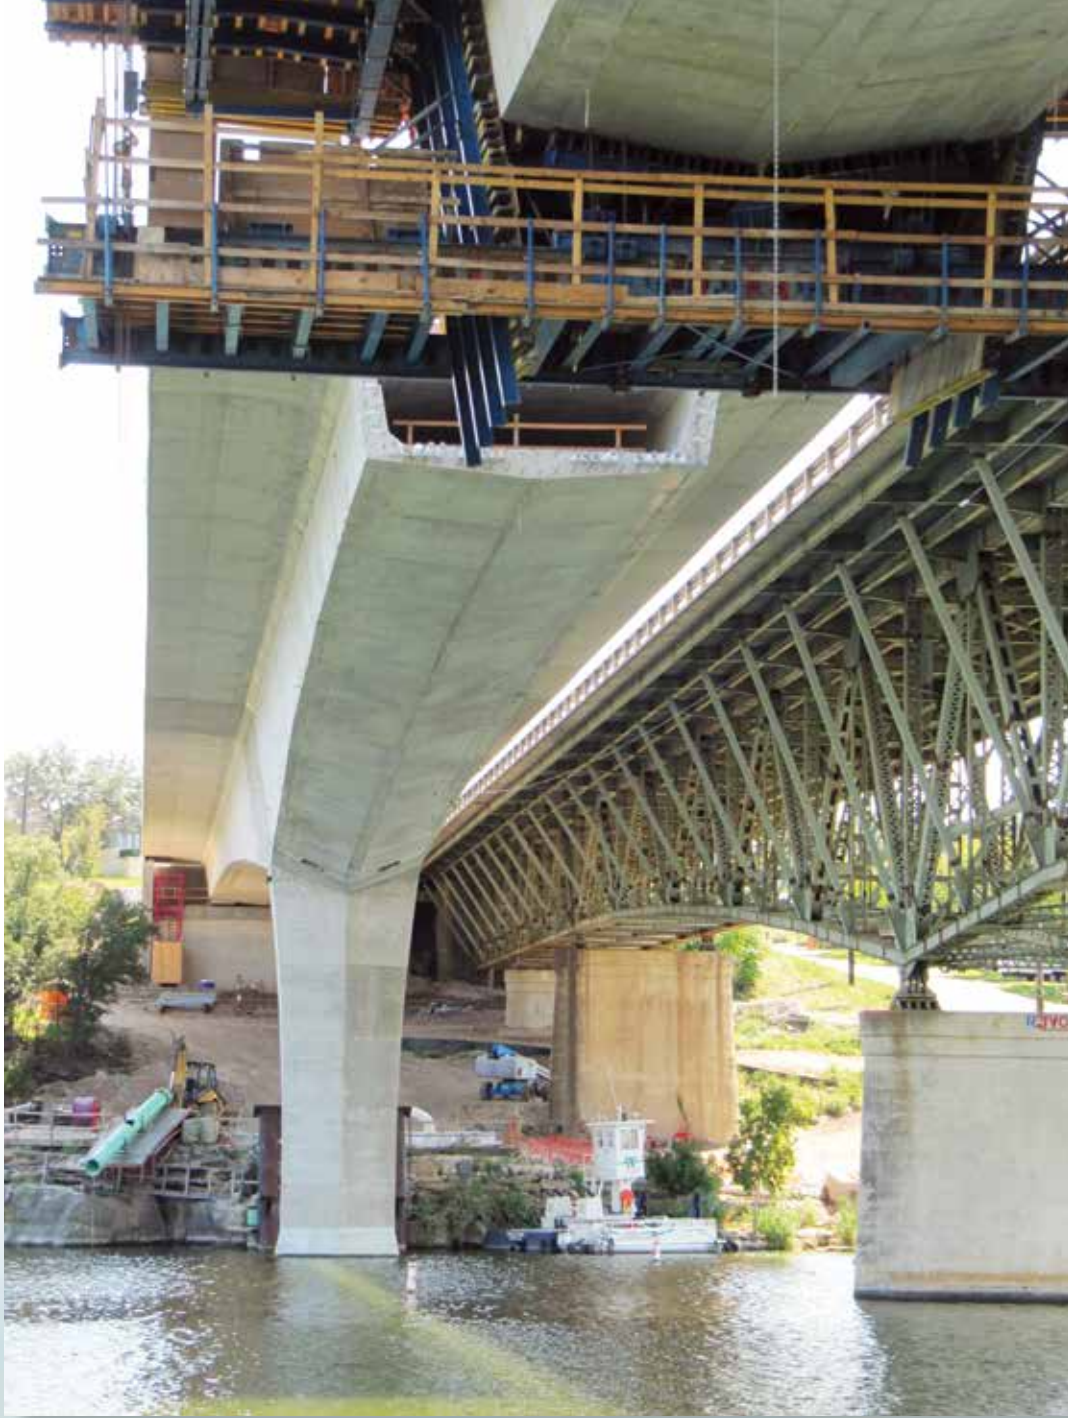
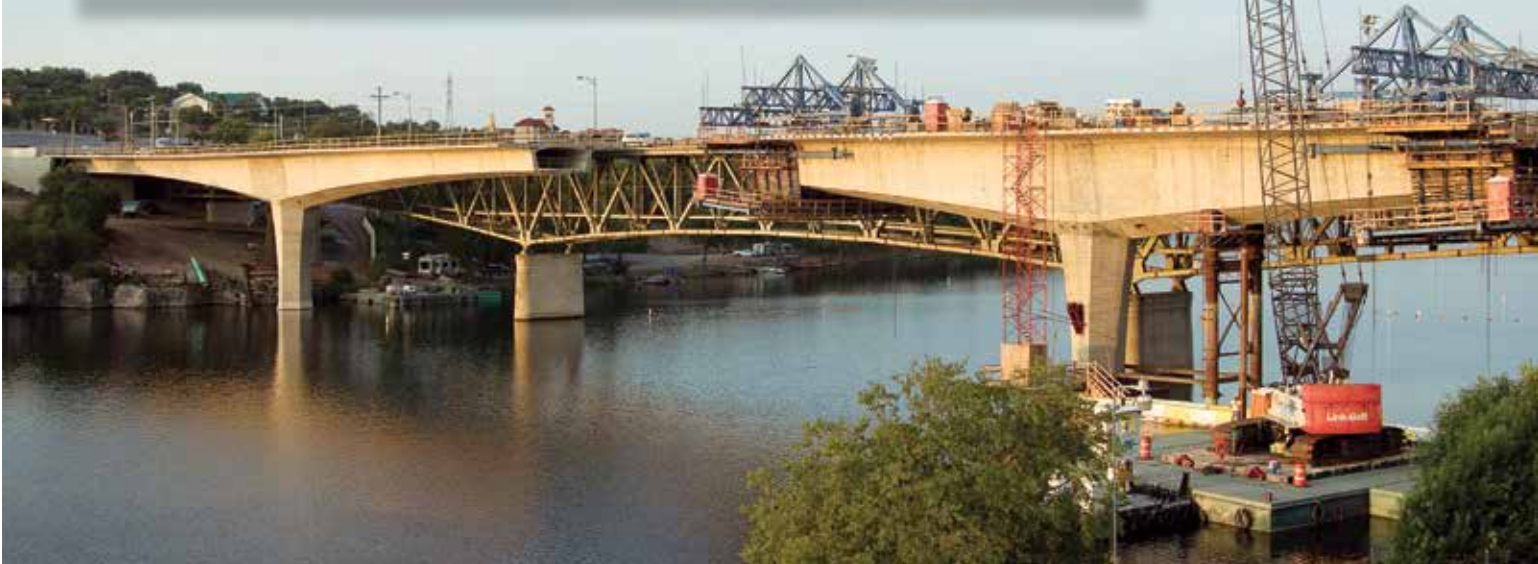
*Figs. 12 and 13 –
US 281 Colorado River Bridge
over Lake Marble Falls.
(Photo Courtesy of
Archer Western Contractors)*
